Manhole Inspection Summary

Manhole # S21M1_013MH

Location Address: **2142 norland-patapsco alley**

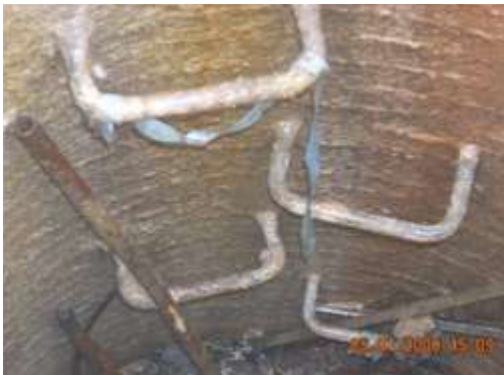
Defect 5

☒ **Evidence Of Surcharge**

Depth: **6** (ft.) ☐ Active Surcharge Present

surcharge evidence

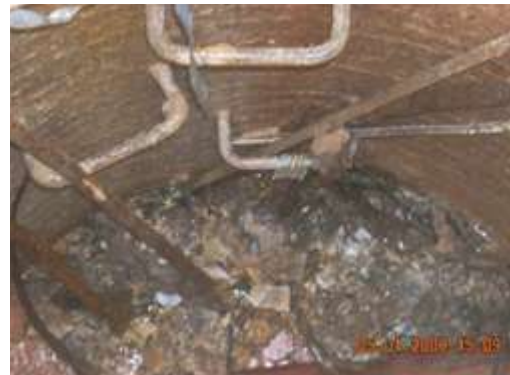
Defect 4

Condition: ☐ Sound ☐ Cracked ☐ Root Intrusion ☐ Deteriorated ☐ Leaks ☒ **Debris**

debris on bench

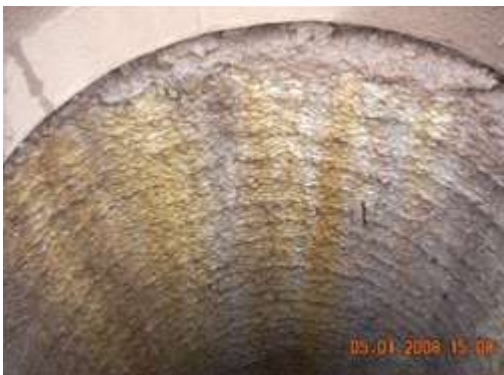
Defect 3

Infiltration: ☐ None ☒ **Joint** ☐ Cracks ☐ Mortar ☐ Roots ☐ Wall

infiltration @ chimney/frame joint,
chimney deteriorating

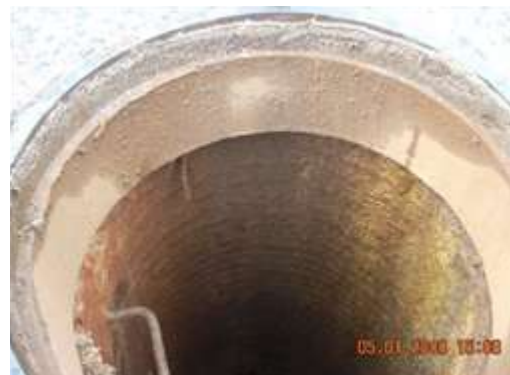
Defect 2

inflow evidence

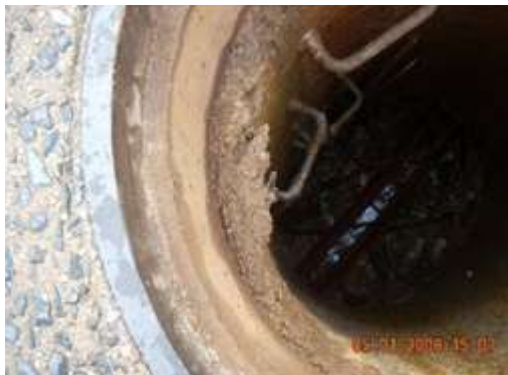
Defect 1

Offset: **1** (in.)

☒ **Leaks**

frame offset, debris in channel and bench

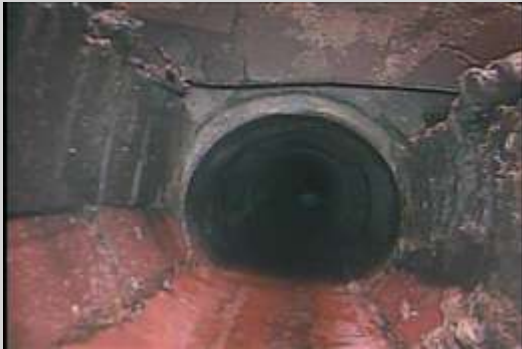
12 O'Clock Outflow

8 in. Circular Gravity Sewer
Pipe Out @ 12 O'Clock

Pipe Height: **8.4** (in.) Rod and Bar (Angled)
Pipe Material: **Clay** ☐ Pipe Lined
Invert Depth: **9.65** (ft.) Flow Characteristics: **Slow**
Deposits: ☒ None ☐ Mud ☐ Sludge ☐ Debris ☐ Grease
Silt Depth: **0** (in.) Deposits Extent:
Infiltration: **None** Pipe Seal Cond: **Sound**

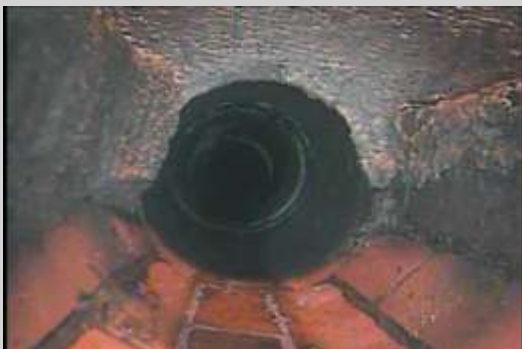
6 O'Clock Inflow

8 in. Circular Gravity Sewer
Pipe In @ 6 O'Clock

Pipe Height: **8.4** (in.) Rod and Bar (Angled)
Pipe Material: **Clay** ☐ Pipe Lined
Invert Depth: **9.50** (ft.) Flow Characteristics: **Slow**
Deposits: ☒ None ☐ Mud ☐ Sludge ☐ Debris ☐ Grease
Silt Depth: **0** (in.) Deposits Extent:
Infiltration: **None** Pipe Seal Cond: **Unknown**
